The United States versus Duarte Nursery, a
Summary of the Hydrological and Biological
Effects of the Tillage as Assessed by the Federal
Expert Team, and Description of the Final
Settlement Agreement

Richard Lis, Ph.D., Calif. Dept. Fish and Wildlife,
Northern Region, Redding

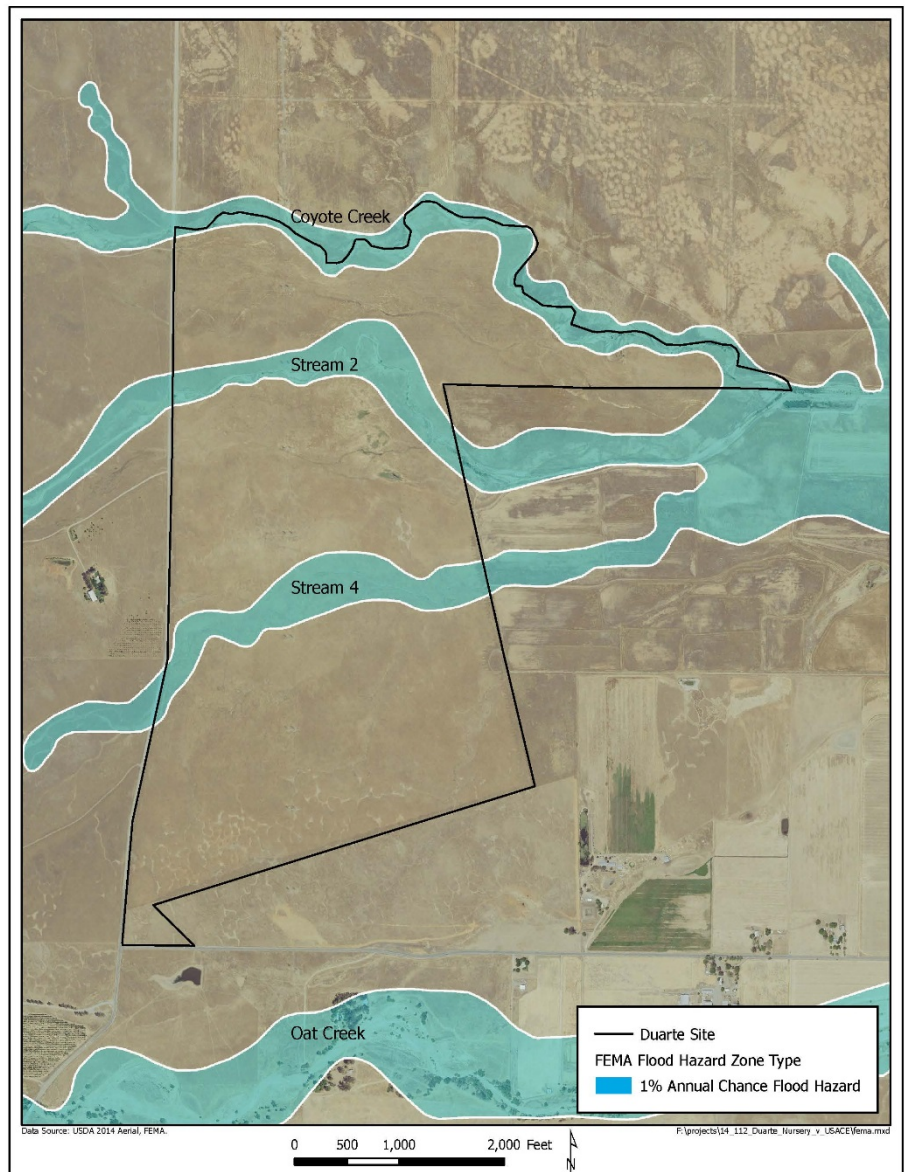
Figure II-7. FEMA Flood Hazard Zones.

Major Watercourses FEMA Flood Hazard Zones

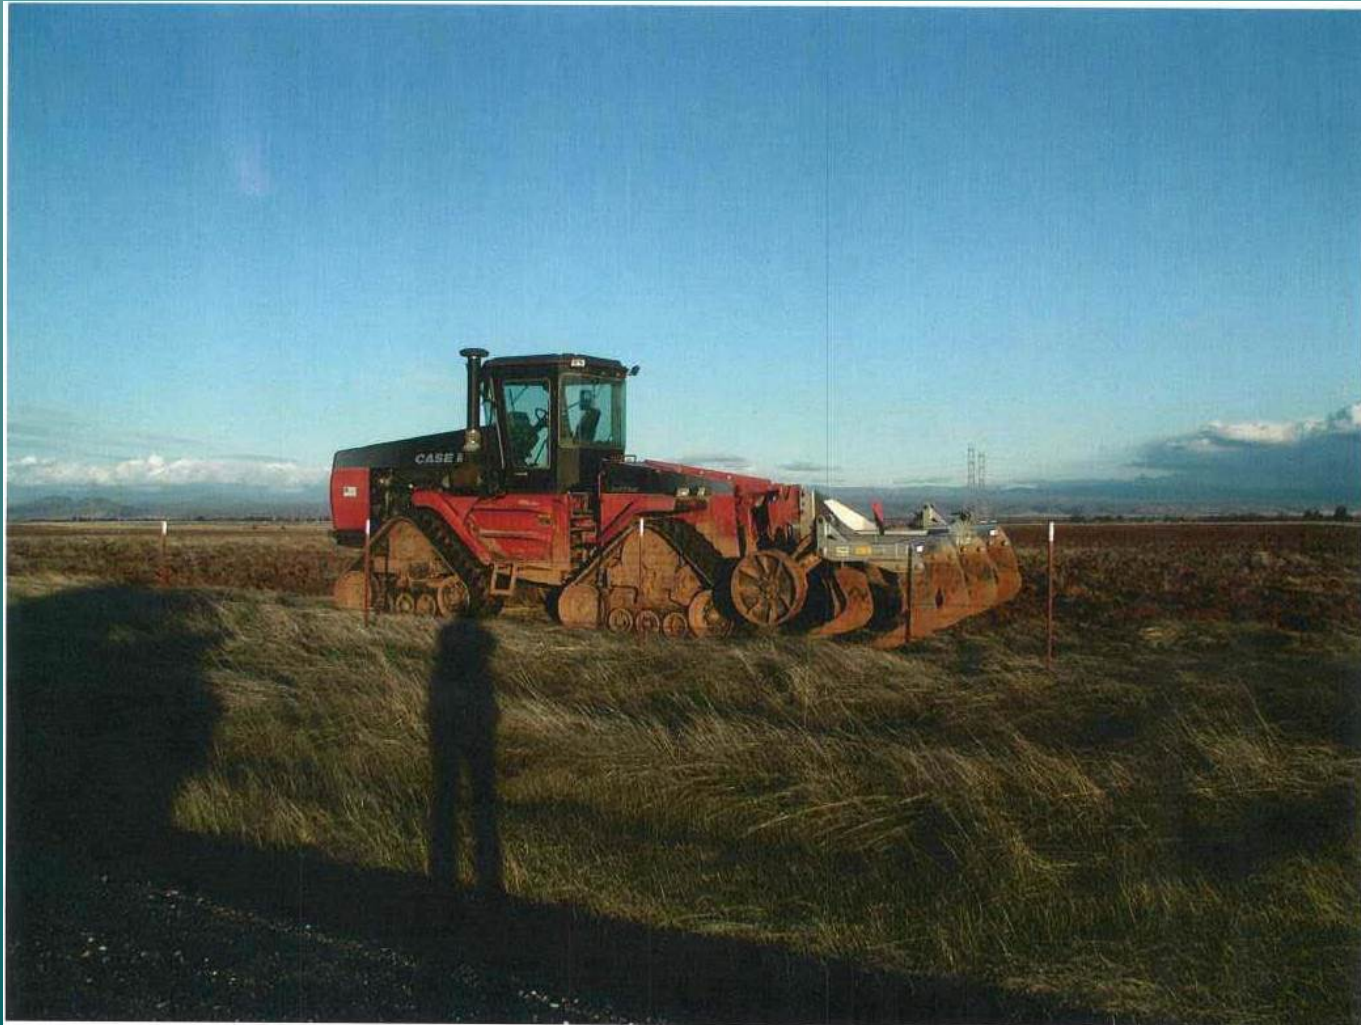
Tillage Implement

International Harvester Quadtrac with
Wilcox Ripper having seven 36" shanks spaced 24" apart.

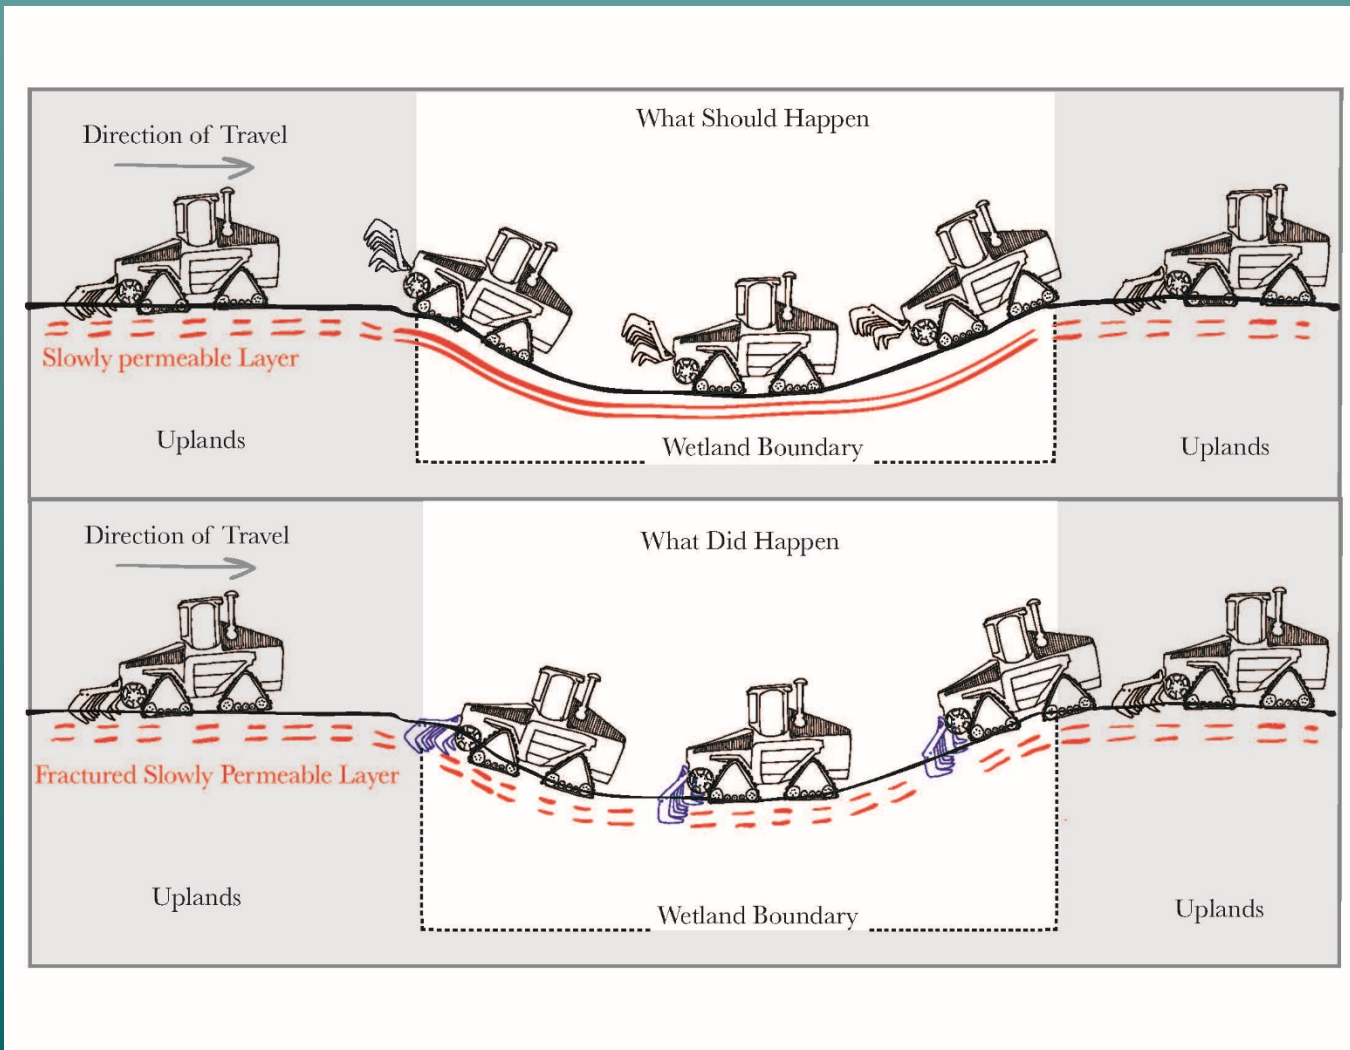
Schematic of tillage operations where ripper is raised, compared to not raised, when crossing wetlands.

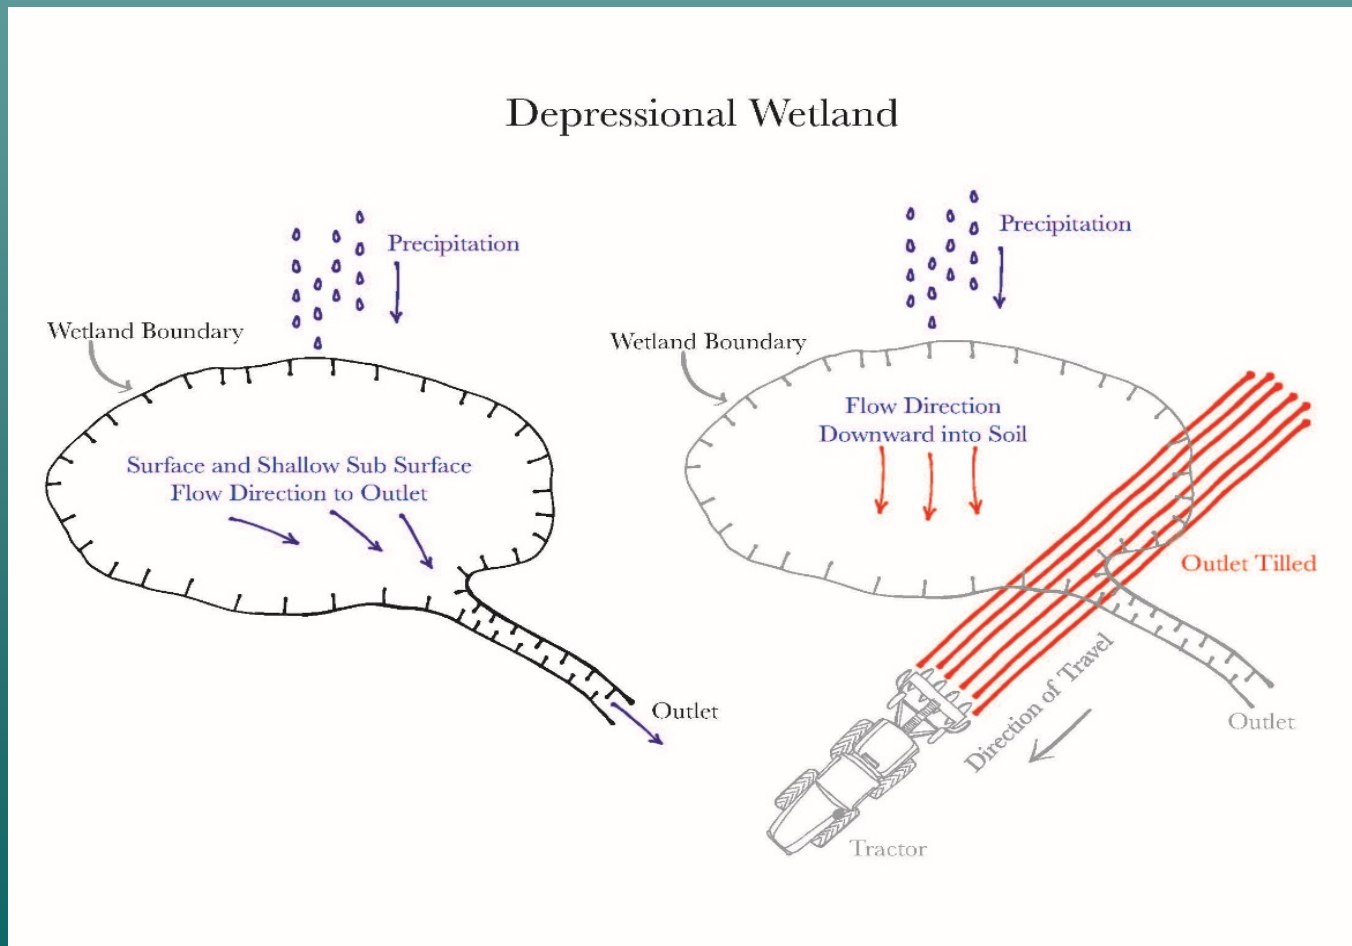
Schematic of tillage across depression outlet changing the patterns of flow and circulation of water from the wetland.

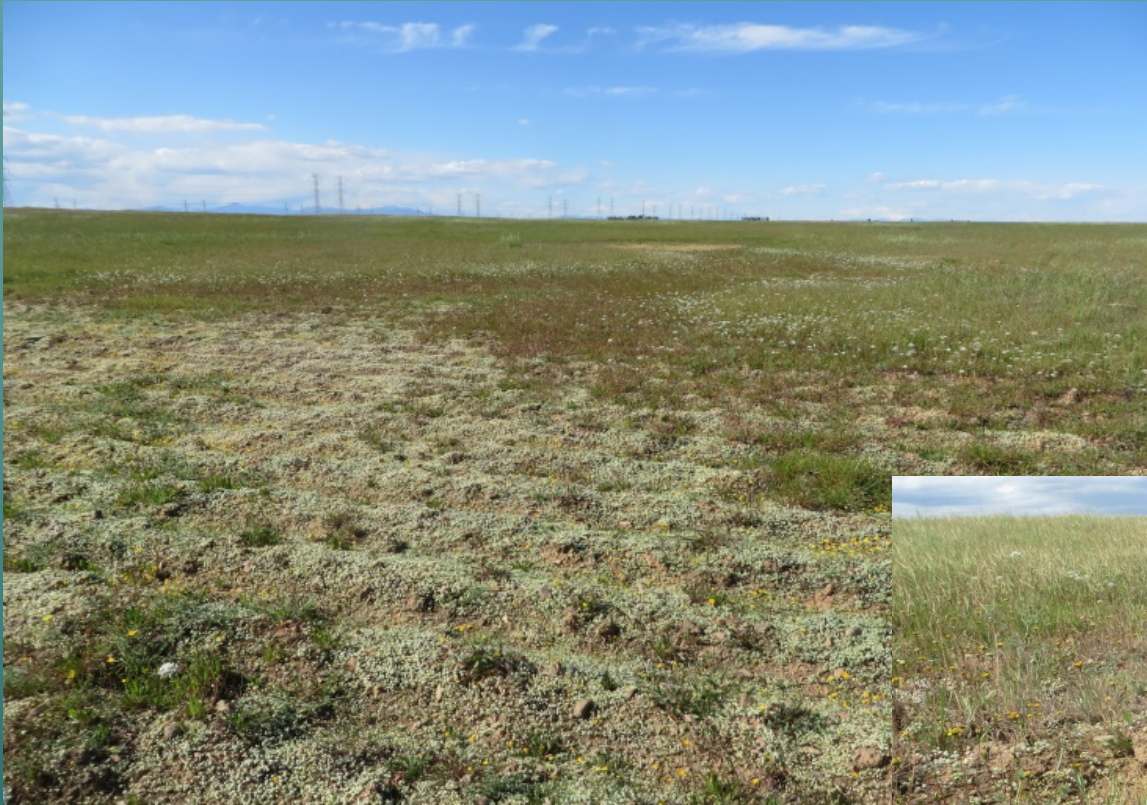
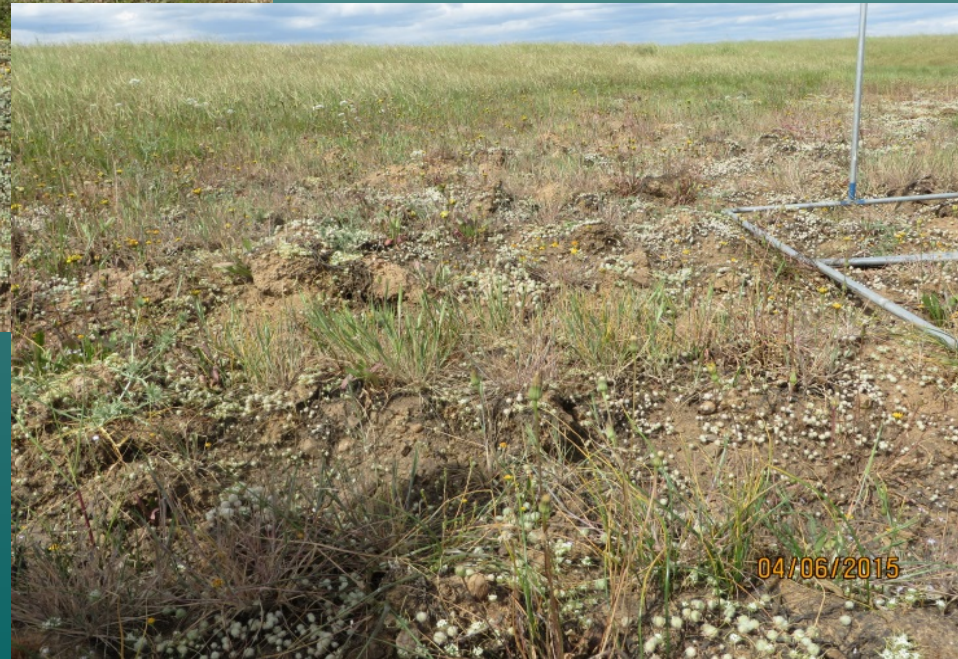
Tillage operations resulting in ridges and troughs in wetlands

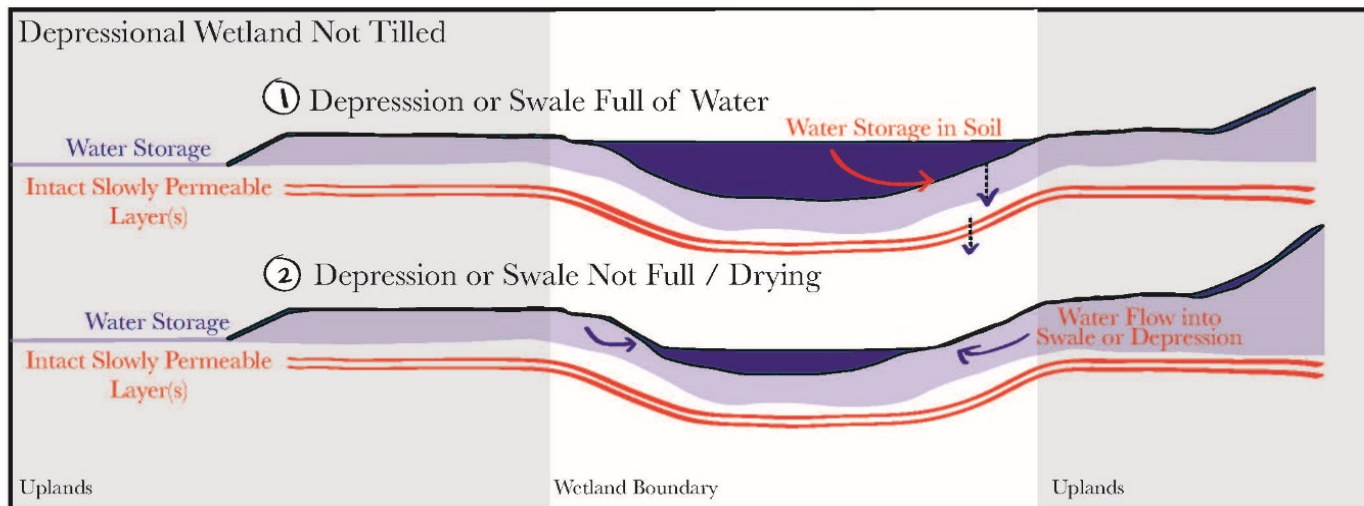
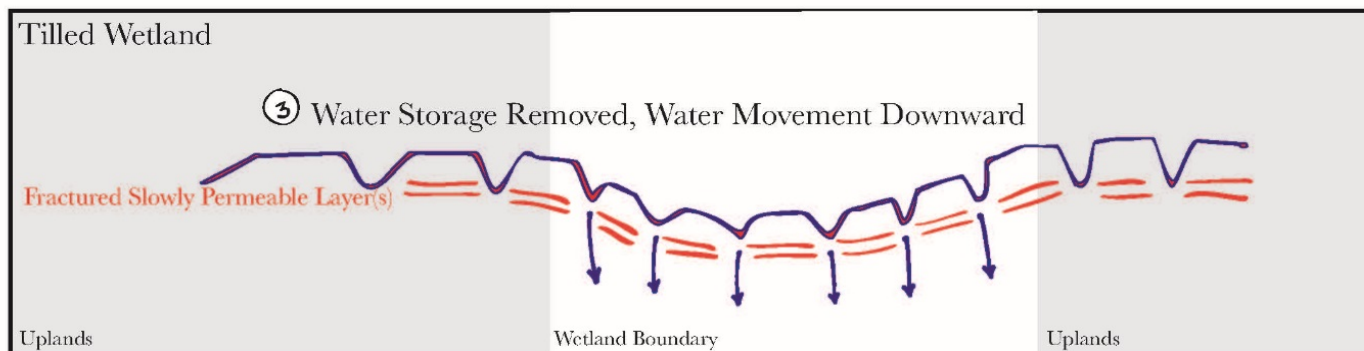
Comparison of hydrologic function of surface and shallow subsurface water storage and exchange in untilled and tilled wetland.

Example of Hydrologic Function: Surface and Shallow Subsurface Water Storage & Exchange

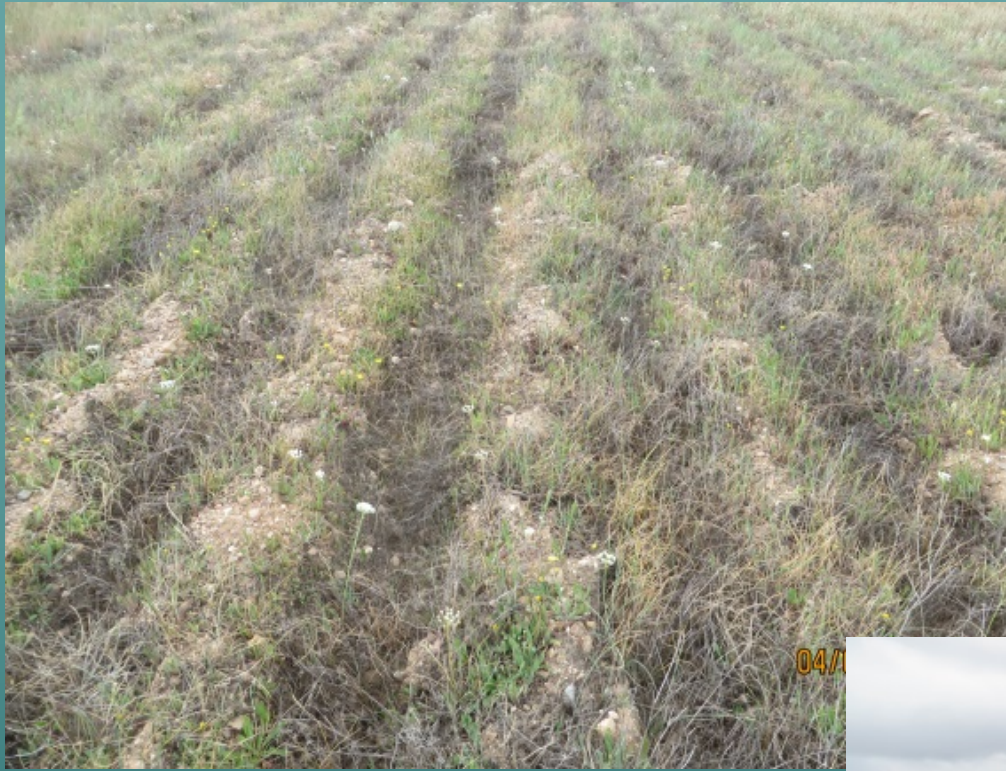
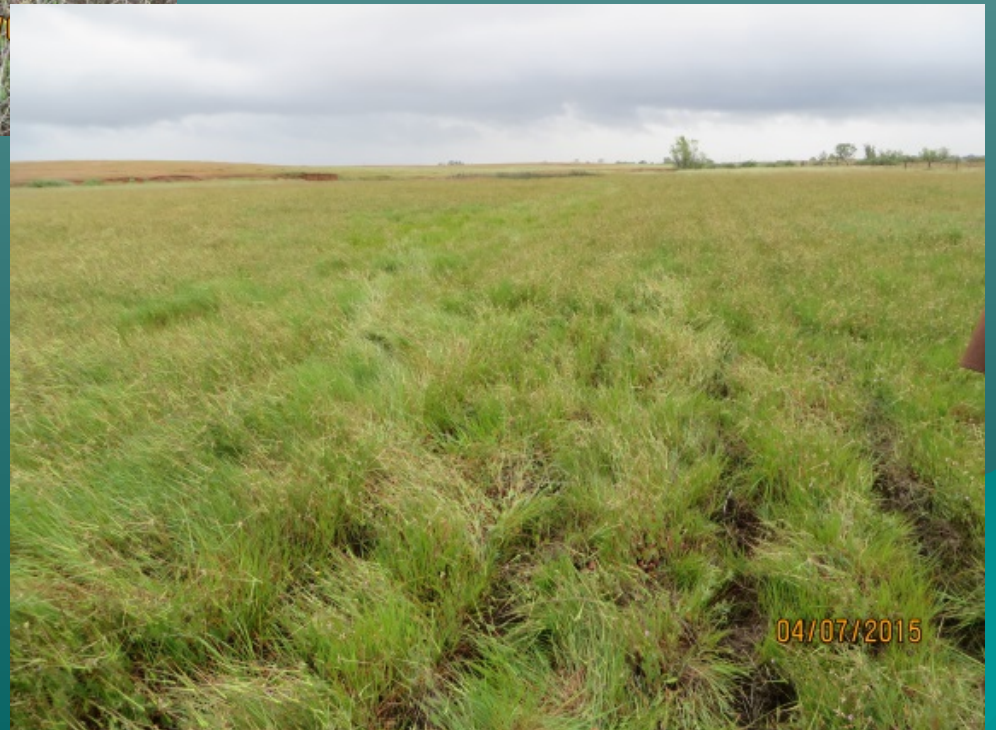
Vegetation growing
on tilled surfaces.
April 2015.

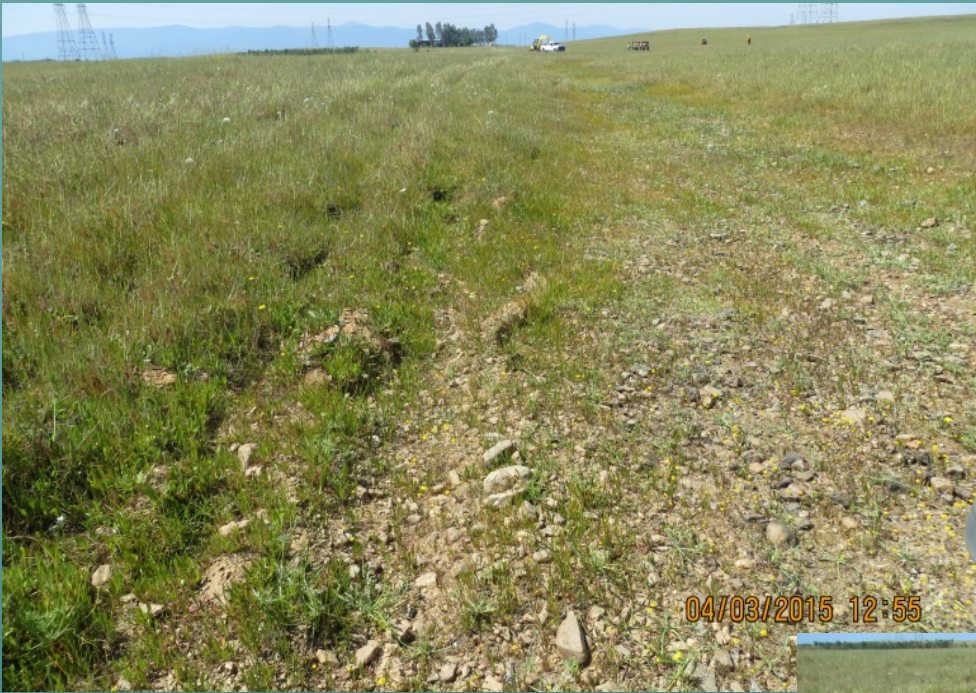
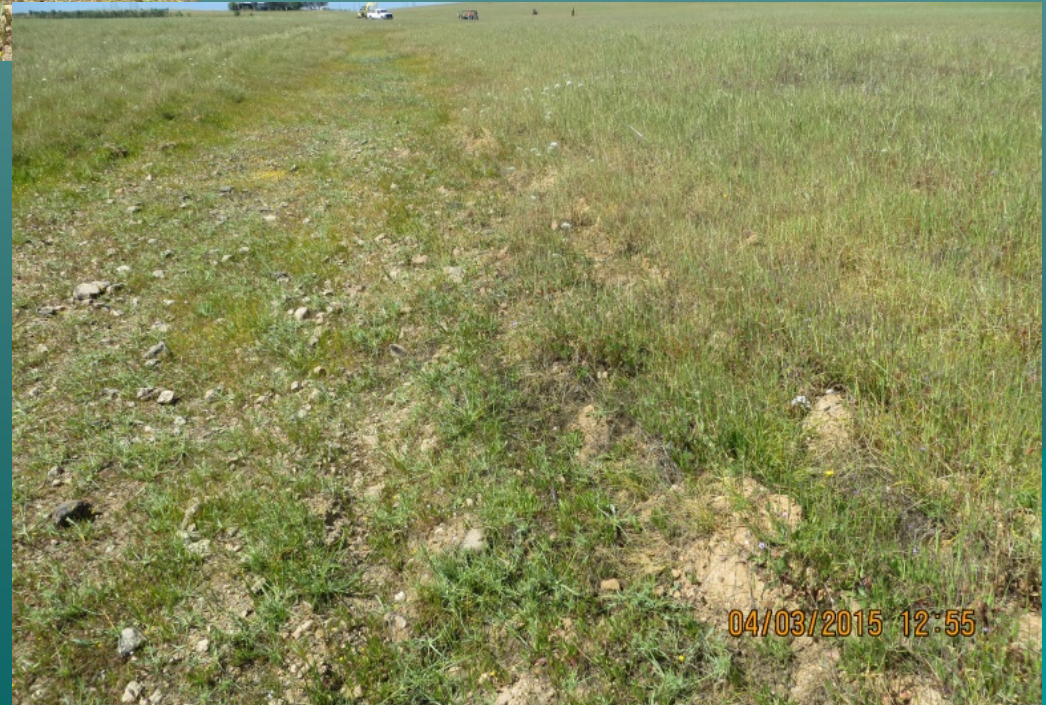
Upland soils dragged
into waters and
wetlands.
April 2015

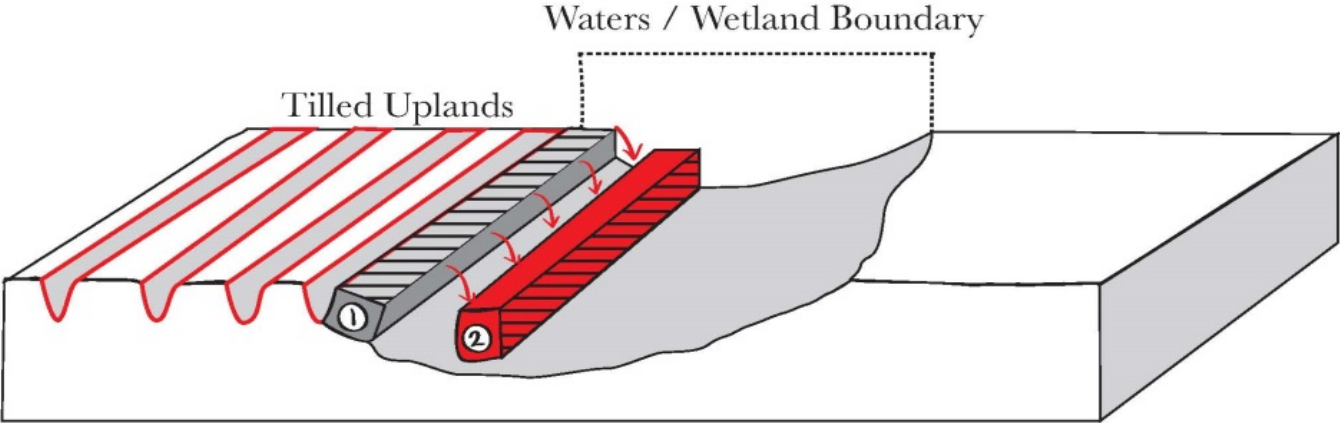
Redistribution and deposition of soil slabs loosened by tillage too close to edges of waters and wetlands.

Slab Sliced and Deposited into Depression

- ① Furrow Soil Slab in Place
- ② Furrow Soil Slab Displaced into Waters/Wetland

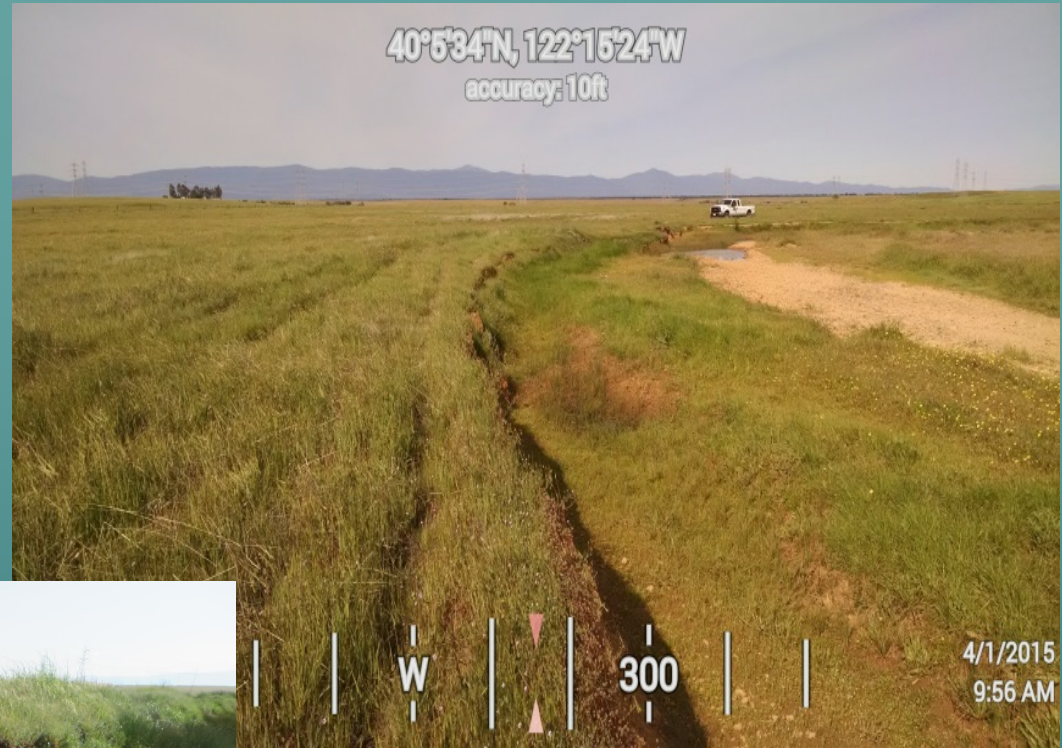
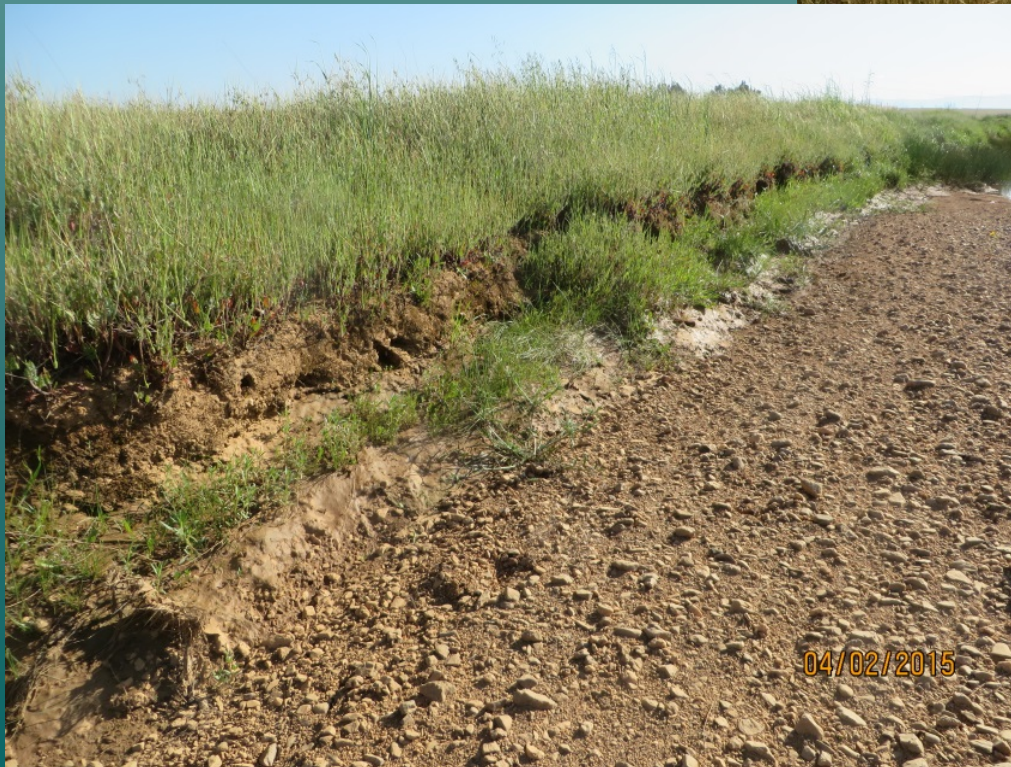
Slab failure in Waters
